**Flood Control Project Maintenance
Levee Inspections**

Maintenance Issue Types Only, Levee Inspection Report By Mile - Spring 2019

Levee District No. 0002 (Glenn County)

Waterway	Bank	Unit Miles	Inspection Start/End	Inspector
Unit No. 01 Glenn County Sacramento River	Right	4.90	04/04/2019 04/04/2019	Makar Sokol

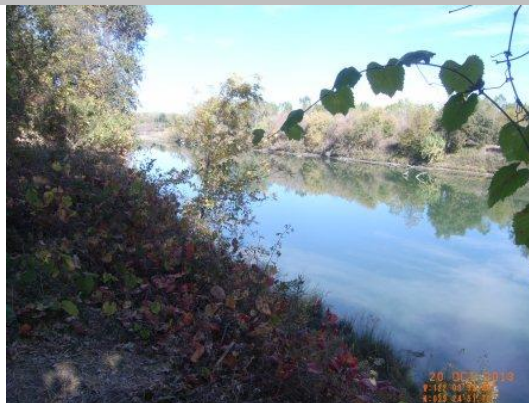
Photo 1 of 2 : SP_2019_LD0002_28_6_20190320_00003.jpg

LM Start	0.07	Rating **	M	Issue No.	6
LM End	0.28	Issue Type +	Ma	Location *	WS
Category	Supplemental			GPS Latitude/Longitude	
				Start	End
Item	2017 USACE Erosion Survey, DRAFT			39.414649 °	39.417689 °
				-122.009853 °	-122.010369 °
DWR ID	DWR_ST0010_02_f_2022_4				
Comment Code					
Inspector Comment					
2017 Site ID: SAC 164.7 R					
Status: Eroding					
2017 Field Notes: New erosion along entire site.					
Site History: 2009 - Very slow retreat, hard toe, encroaching into the levee projection. 2010 - Slowly eroding. 2011 - Site extended downstream.

USACE 2013 Photo #1

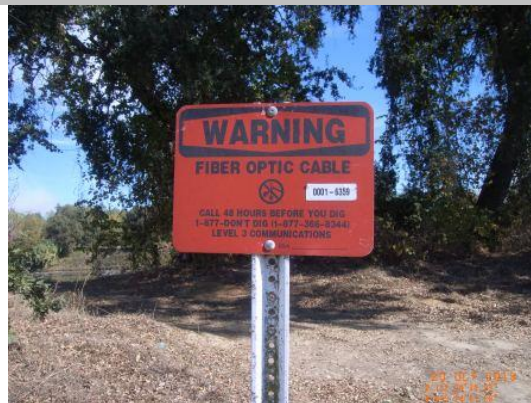
Photo 2 of 2 : SP_2019_LD0002_28_6_20190320_00004.jpg

LM Start	0.07	Rating **	M	Issue No.	6 (cont)	
LM End	0.28	Issue Type +	Ma	Location *	WS	
Category	Supplemental			GPS Latitude/Longitude		
				Start		End
Item	2017 USACE Erosion Survey, DRAFT			39.414649 °		39.417689 °
				-122.009853 °		-122.010369 °
DWR ID	DWR_ST0010_02_f_2022_4					
Comment Code						
Inspector Comment						
2017 Site ID: SAC 164.7 R						
Status: Eroding						
2017 Field Notes: New erosion along entire site.						
Site History: 2009 - Very slow retreat, hard toe, encroaching into the levee projection. 2010 - Slowly eroding. 2011 - Site extended downstream.

USACE 2013 Photo #2

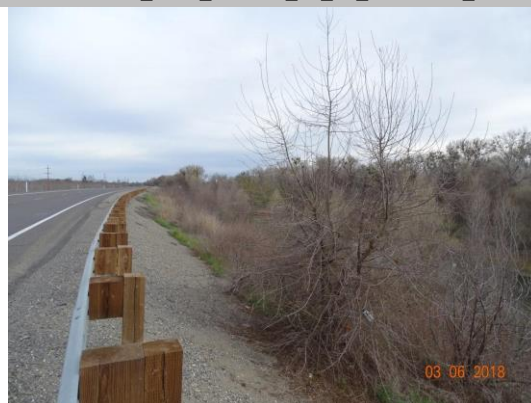
Photo 1 of 1 : SP_2019_LD0002_28_35_20190320_00017.jpg

LM Start	0.64	Rating **	M	Issue No.	35
LM End	0.77	Issue Type +	Ma	Location *	WS
Category	Earthen Levee			GPS Latitude/Longitude	
				Start	End
Item	Vegetation			39.422805 °	39.424597 °
				-122.011640 °	-122.011527 °
DWR ID	DWR_LD0002_01_s_2018_35				
Comment Code					
V2 : Remove the wild growth other than native grasses from the levee slopes.					
Inspector Comment

View of the vegetation along the waterside slope.

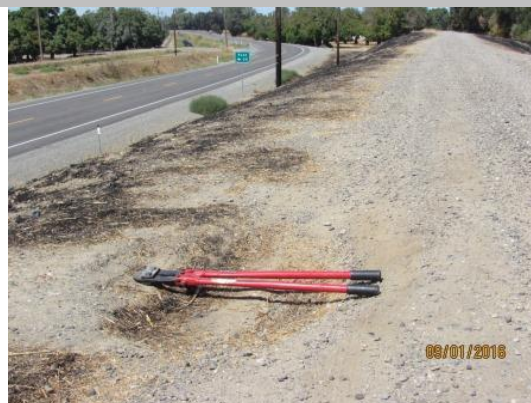
Photo 1 of 1 : SP_2019_LD0002_28_34_20190320_00016.jpg

LM Start	1.40	Rating **	M	Issue No.	34
LM End	1.40	Issue Type +	Ma	Location *	CR
Category	Earthen Levee			GPS Latitude/Longitude	
				Start	End
Item	Crown Surface / Depressions / Rutting			39.433809 °	39.433809 °
				-122.010814 °	-122.010814 °
DWR ID	DWR_LD0002_01_f_2016_34				
Comment Code					
C2 : Repair depressions or ruts in the crown or slope.					
Inspector Comment

View of a depression on the levee crown looking upstream.

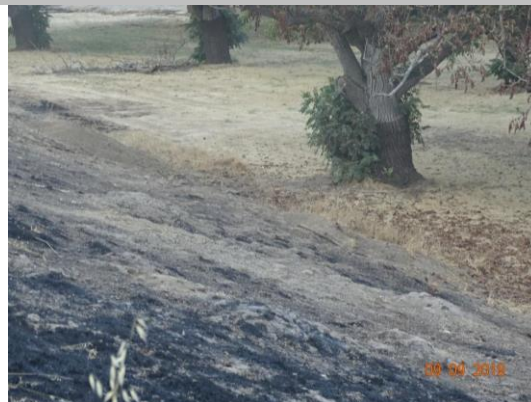
Photo 1 of 1 : SP_2019_LD0002_28_15_20190320_00007.jpg

LM Start	1.52	Rating **	U	Issue No.	15
LM End	1.60	Issue Type +	Ma	Location *	LS
Category	Earthen Levee			GPS Latitude/Longitude	
				Start	End
Item	Animal Control			39.435485 °	39.436643 °
				-122.010640 °	-122.010498 °
DWR ID	DWR_LD0002_01_f_2012_15				
Comment Code					
A3 : No rodents visible, but rodent burrows visible; need to backfill and compact or grout burrows.					
Inspector Comment

View of the rodent holes along the landside slope.

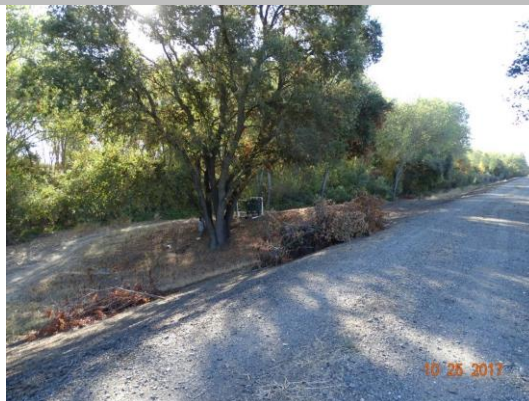
Photo 1 of 1 : SP_2019_LD0002_28_32_20190320_00015.jpg

LM Start	1.63	Rating **	M	Issue No.	32
LM End	1.63	Issue Type +	Ma	Location *	WS
Category	Earthen Levee			GPS Latitude/Longitude	
				Start	End
Item	Encroachments			39.437148 °	39.437148 °
				-122.010475 °	-122.010475 °
DWR ID	DWR_LD0002_01_f_ 2017_32				
Comment Code					
PR : Prunings					
Inspector Comment					
Remove the prunings from the waterside slope.

View of the prunings along the waterside slope.

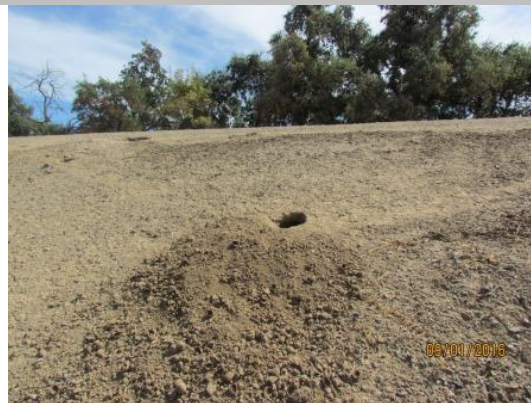
Photo 1 of 4 : SP_2019_LD0002_28_16_20190320_00008.jpg

LM Start	3.23	Rating **	U	Issue No.	16
LM End	3.30	Issue Type +	Ma	Location *	LS
Category	Earthen Levee			GPS Latitude/Longitude	
				Start	End
Item	Animal Control			39.456192 °	39.456272 °
				-122.011445 °	-122.010163 °
DWR ID	DWR_LD0002_01_f_2012_16				
Comment Code					
A3 : No rodents visible, but rodent burrows visible; need to backfill and compact or grout burrows.					
Inspector Comment

View of the rodent holes along the landside slope.

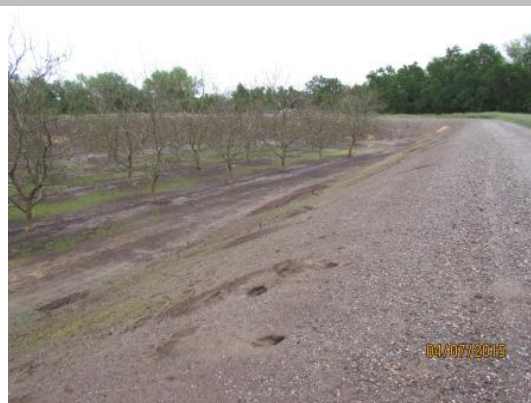
Photo 2 of 4 : SP_2019_LD0002_28_16_20190320_00009.jpg

View of the rodent holes along the landside slope.

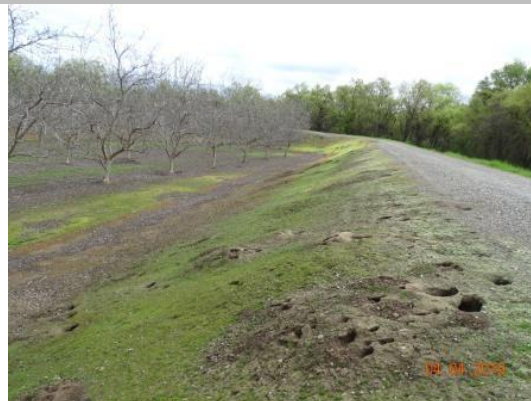
Photo 3 of 4 : SP_2019_LD0002_28_16_20190411_00053.jpg

View of the rodent holes along the landside slope. Spring 2019.

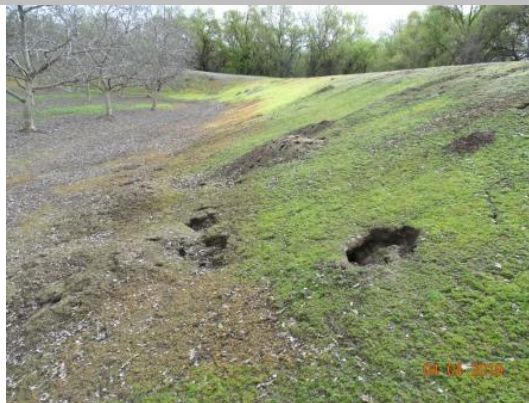
Photo 4 of 4 : SP_2019_LD0002_28_16_20190411_00054.jpg

LM Start	3.23	Rating **	U	Issue No.	16 (cont)	
LM End	3.30	Issue Type +	Ma	Location *	LS	
Category	Earthen Levee			GPS Latitude/Longitude		
				Start		End
Item	Animal Control			39.456192 °		39.456272 °
				-122.011445 °		-122.010163 °
DWR ID	DWR_LD0002_01_f_2012_16					
Comment Code						
A3 : No rodents visible, but rodent burrows visible; need to backfill and compact or grout burrows.						
Inspector Comment

Another view of the rodent holes along the landside slope. Spring 2019.

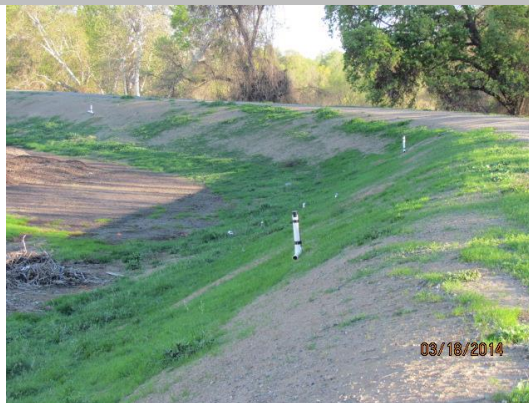
Photo 1 of 2 : SP_2019_LD0002_28_27_20190320_00011.jpg

LM Start	3.44	Rating **	U	Issue No.	27
LM End	3.52	Issue Type +	Ma	Location *	LS
Category	Earthen Levee			GPS Latitude/Longitude	
				Start	End
Item	Animal Control			39.457692 °	39.458705 °
				-122.009517 °	-122.009872 °
DWR ID	DWR_LD0002_01_s_2014_27				
Comment Code					
A3 : No rodents visible, but rodent burrows visible; need to backfill and compact or grout burrows.					
Inspector Comment

View of the rodent activity along the landside slope.

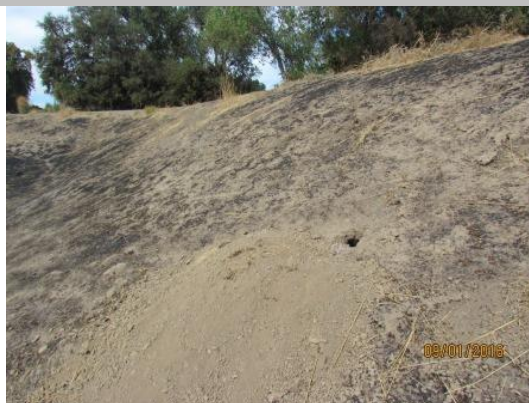
Photo 2 of 2 : SP_2019_LD0002_28_27_20190320_00012.jpg

View of the rodent holes along the landside slope.

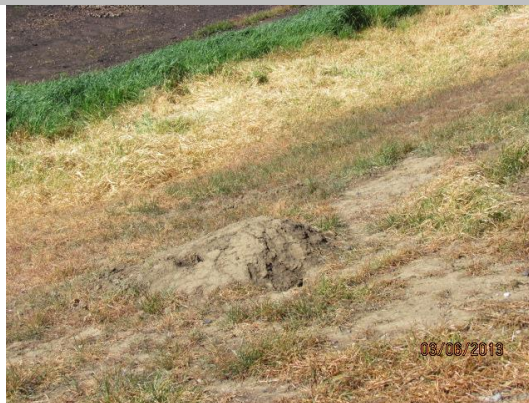
Photo 1 of 1 : SP_2019_LD0002_28_13_20190320_00006.jpg

LM Start	3.53	Rating **	U	Issue No.	13
LM End	3.57	Issue Type +	Ma	Location *	LS
Category	Earthen Levee			GPS Latitude/Longitude	
				Start	End
Item	Animal Control			39.458803 °	39.459305 °
				-122.009980 °	-122.010511 °
DWR ID	DWR_LD0002_01_s_2013_13				
Comment Code					
A3 : No rodents visible, but rodent burrows visible; need to backfill and compact or grout burrows.					
Inspector Comment

View of the rodent activity along the landside slope.

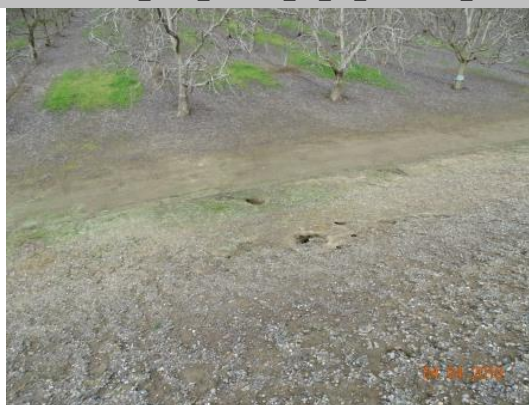
Photo 1 of 1 : SP_2019_LD0002_28_50_20190411_00055.jpg

LM Start	3.79	Rating **	M	Issue No.	50
LM End	3.79	Issue Type +	Ma	Location *	LS
Category	Earthen Levee			GPS Latitude/Longitude	
				Start	End
Item	Animal Control			39.462358 °	39.462358 °
				-122.011623 °	-122.011623 °
DWR ID	DWR_LD0002_01_s_2019_50				
Comment Code					
A3 : No rodents visible, but rodent burrows visible; need to backfill and compact or grout burrows.					
Inspector Comment

View of the rodent holes on the landside slope. Spring 2019.

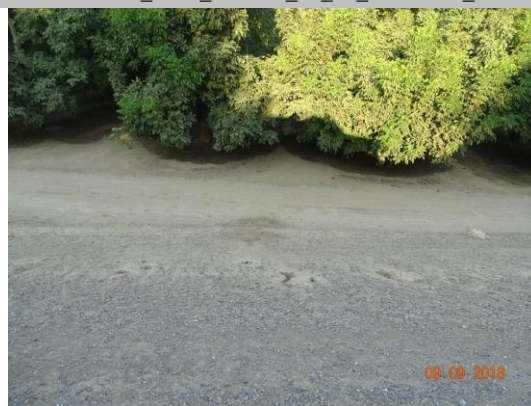
Photo 1 of 1 : SP_2019_LD0002_28_28_20190320_00013.jpg

LM Start	4.00	Rating **	M	Issue No.	28
LM End	4.02	Issue Type +	Ma	Location *	LS
Category	Earthen Levee			GPS Latitude/Longitude	
				Start	End
Item	Animal Control			39.465418 °	39.465657 °
				-122.011235 °	-122.011237 °
DWR ID	DWR_LD0002_01_f_2018_28				
Comment Code					
A3 : No rodents visible, but rodent burrows visible; need to backfill and compact or grout burrows.					
Inspector Comment

View of the rodent holes along the landside slope.
